# Evaluation Report 236

## New Holland Model 310 Baler

# NEW HOLLAND MODEL 310 BALER

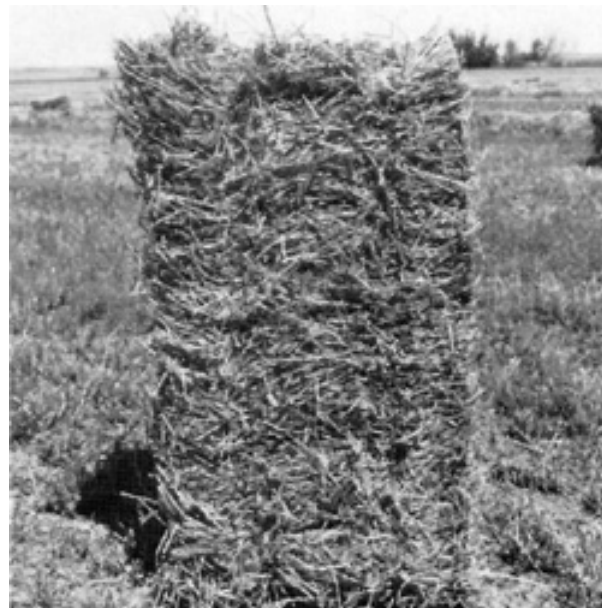
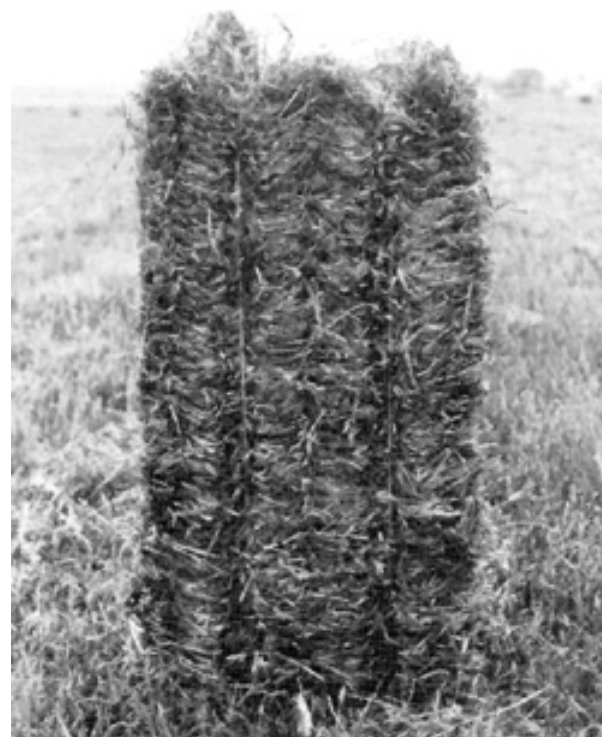
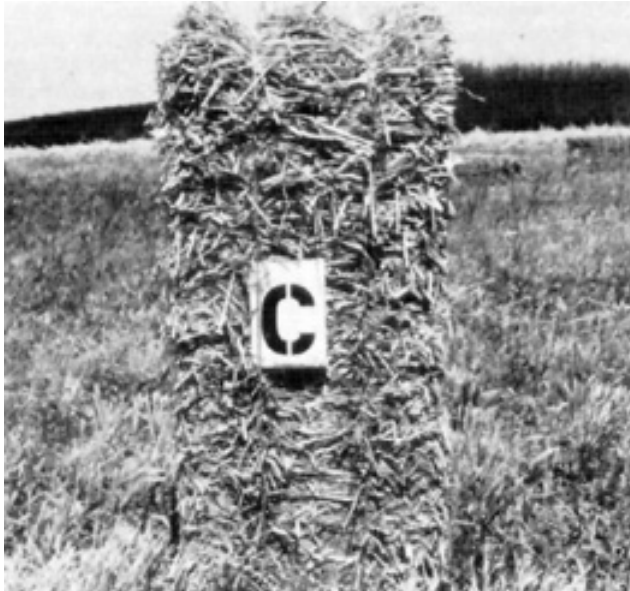
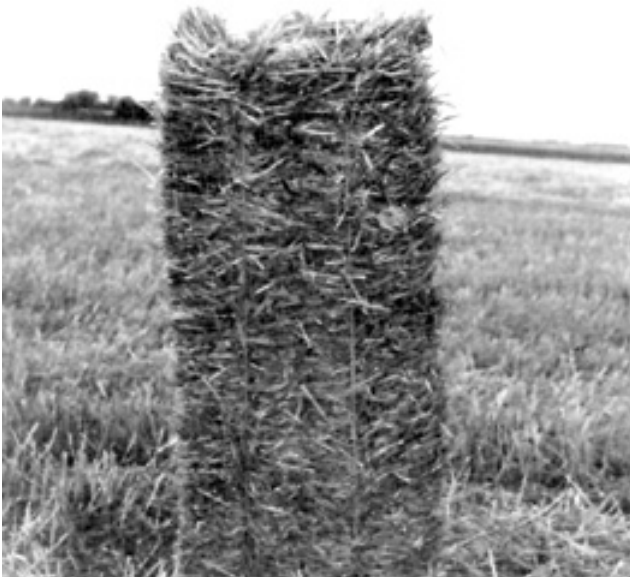
FIGURE 2. Typical Bales: (A) Alfalfa, (B) Sornegrass, (C) Greenfeed, (D) Straw.

**Bale Quality:** At normal feedrates the New Holland 310 was capable of producing firm, durable bales with square ends in all crops (FIGURE 2). Average hay bales weighed 27 to 35 kg (59 to 77 lb), while average straw bales weighed 18 to 22 kg (40 to 48 lb). Average bale densities varied from 174 to 205 kg/m<sup>3</sup> (10.4 to 12.3 lb/ft<sup>3</sup>) in hay and 115 to 123 kg/m<sup>3</sup> (6.9 to 7.4 lb/ft<sup>3</sup>) in straw. Bale quality deteriorated at higher feedrates.

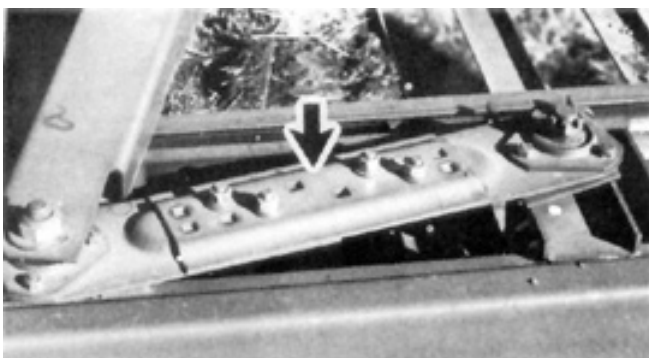
FIGURE 6. Feeder Sled Link Adjustment.

**Feeding System:** Feeder carriage penetration was easily adjusted by lengthening or shortening the feeder sled link (FIGURE 6). The feeder sled link had five settings which required the use of wrenches. This adjustment was usually sufficient to produce square, well formed bales in most crops. Additional adjustment of the feeder back could also be used to improve bale shape. The feeder back was easily adjusted with wrenches.
